HERA Report No R4-150:2017

The seismic performance of structural steel buildings in the 2016 Kaikoura Earthquake

Alistair Fussell, BE (Hon), ME, MIPENZ, CPEng

Senior Engineer and Director Tangent Consulting

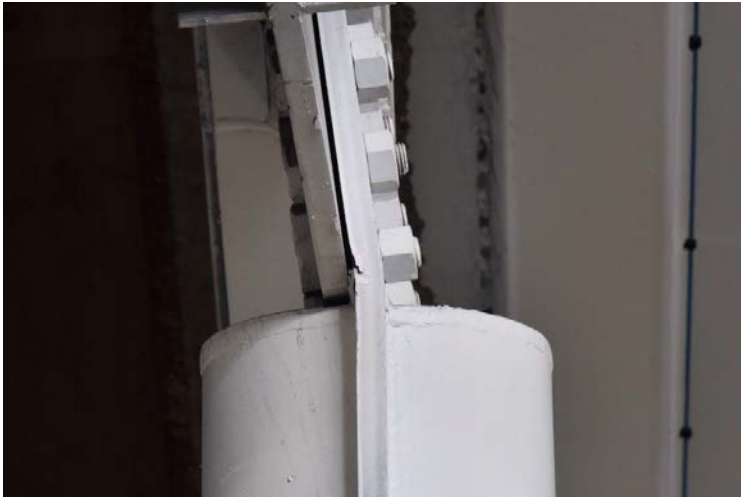
A number of the brace to collector beam gusset plate connections buckled out of plane; see Figure 5. It is not known if the structure experienced other forms of structural damage. Nor is it known if the active links yielded during the ground shaking.

The observed buckling is consistent with a gusset plate sway mode of failure.

Figure 5 - Out of plane buckling of eccentric cleat connection

For Damage Case 1, the significance of factors a) and b) is unknown, while factor c) was present.

It is unknown how the gusset plate support structure performed; based on the observed damage it appears to have insufficient rotational strength and stiffness to prevent the mechanism forming.

The observed damage highlights the vulnerability of gusset plate connections to a sway mode of failure. The presence of an eccentric connection would have very significantly increased the out-of-plane actions the gusset plate connection was subject to during the earthquake. The design of such connections must appropriately consider out-of-plane design actions and eccentric cleats in compression for other than category 4 seismic resisting systems are specifically not recommended by HERA [15].

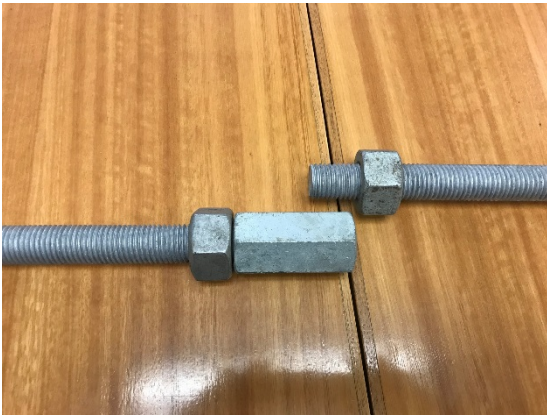
Figure 8 - Engineering round coupler detail. (Note: lock nuts not used in braces that failed)

The damage reported for this building was the failure of the bracing coupler devices that unscrewed during the earthquake. It appears there was sufficient structural redundancy to ensure that the structure remained stable with reduced lateral load resistance following failure of some of the brace coupling devices.

Similar problems were observed with a proprietary bracing system during the Canterbury earthquake sequence of 2010 and 2011, where the connection failures were attributed to the restraining nuts being loose prior to the earthquake and so causing impact loading on the bracing system during the earthquake.

This failure highlights the importance of using lock nuts in connection devices in tension only bracing elements to prevent connection failure during cyclic loading.

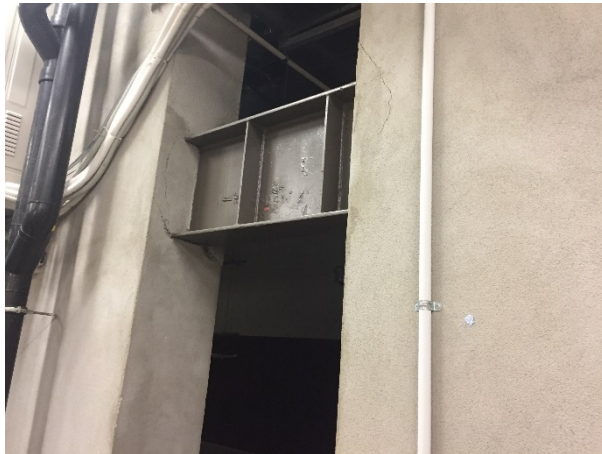
The coupled shear walls behaved as designed with evidence of shear yielding (paint flaking) in the wall coupling beams, see Figure 9. In the East-West direction the active links underwent some 8% plastic strain and were cut out and replaced. Links in the north-south direction underwent negligible visible yielding [13]. Studies undertaken by Dr Charles Clifton using the procedure developed for eccentrically braced frames (EBF) post-earthquake assessment [16] showed the links were at the threshold of needing replacement and the decision was made to replace them; this was done in 2017.

Figure 9 - Structural steel coupler beam exhibiting evidence of yielding (paint flaking)
