HERA Report No R4-150:2017

The seismic performance of structural steel buildings in the 2016 Kaikoura Earthquake

Alistair Fussell, BE (Hon), ME, MIPENZ, CPEng

Senior Engineer and Director Tangent Consulting

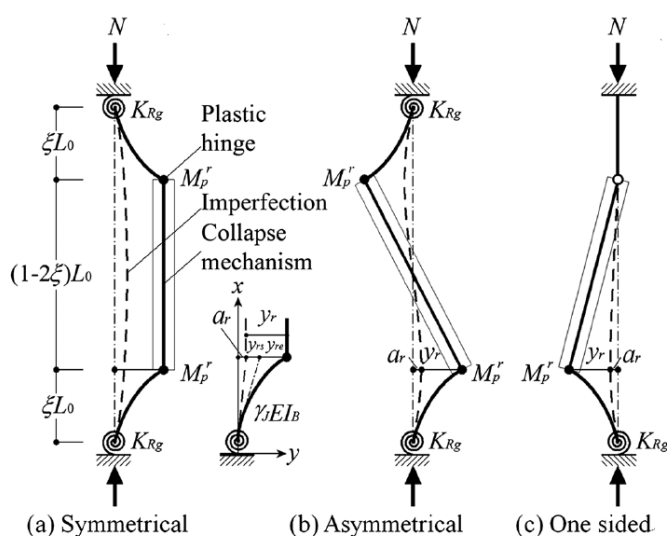
Figure 6 - Collapse mechanisms for braces with gusset connections [13]

Sway buckling behaviour is a global stability phenomenon in which the brace system comprising brace and end connections forms a collapse mechanism, see Figure 6. Several collapse mechanisms are possible, but the mechanism with the lowest capacity will be the critical case. Under such a failure condition, the gusset plate is subject to out of plane actions arising from various sources such as:

- a. initial imperfection in the brace (out of plumb) and out-of-flatness of the gusset plate;
- b. out-of-plane seismic drifts. Researchers have only recently recognised the significance of out-of-plane drifts on the behaviour of gusset plate connections [13]; and
- c. eccentricity in the connection.

For Damage Case 1, the significance of factors a) and b) is unknown, while factor c) was present.

The unstiffened cleat at the end of the brace would have offered limited out-of-plane strength and stiffness. Once the cleat buckled, forming a hinge between the end of the brace and the gusset plate, the compressive capacity of the system would have been limited by the rotational strength and stiffness of the gusset plate and its support structure, represented by springs in Figure 6. The gusset support structure consisted of an I-beam with full depth stiffeners and a bottom flange lateral restraint element (angle section) at each end of the active link. It is likely the top flange of the collector beam was connected to the slab via shear studs.

It is unknown how the gusset plate support structure performed; based on the observed damage it appears to have insufficient rotational strength and stiffness to prevent the mechanism forming.

The observed damage highlights the vulnerability of gusset plate connections to a sway mode of failure. The presence of an eccentric connection would have very significantly increased the out-of-plane actions the gusset plate connection was subject to during the earthquake. The design of such connections must appropriately consider out-of-plane design actions and eccentric cleats in compression for other than category 4 seismic resisting systems are specifically not recommended by HERA [15].

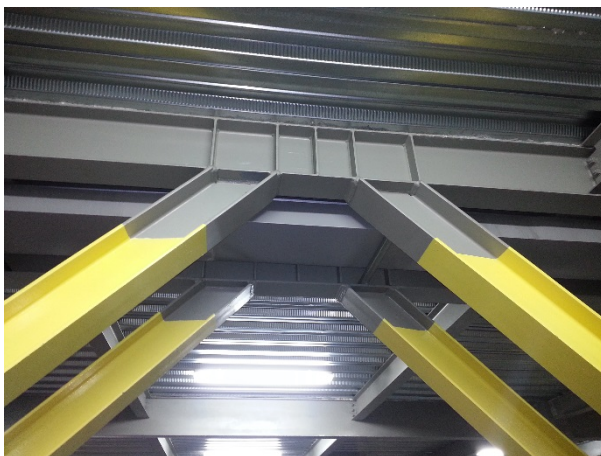
Figure 7 - UC braces welded to the underside of collector beam

Eccentrically braced frame system generally performed well during the Canterbury earthquake sequence of 2010 and 2011. This type of gusset plate connection failure was not observed in Christchurch. This is likely attributable to differences in frame and connection details. In particular, open section braces (Universal Columns) and fully welded brace/ collector beam connections were commonly used, see Figure 7. These types of details provide not only a concentric connection detail, but the brace itself with a welded connection to the underside of the collector beam provides reasonable resistance to out of plane buckling modes of behaviour.
